COLD SPRING DAM (UPPER)

PUTNAM COUNTY, NEW YORK

INVENTORY NO. N.Y. 106

PHASE I INSPECTION REPORT  
NATIONAL DAM SAFETY PROGRAM.

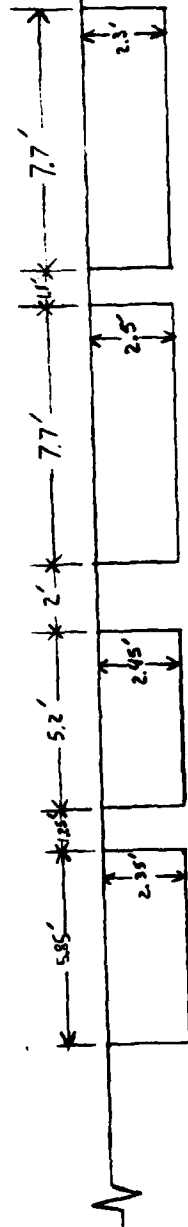
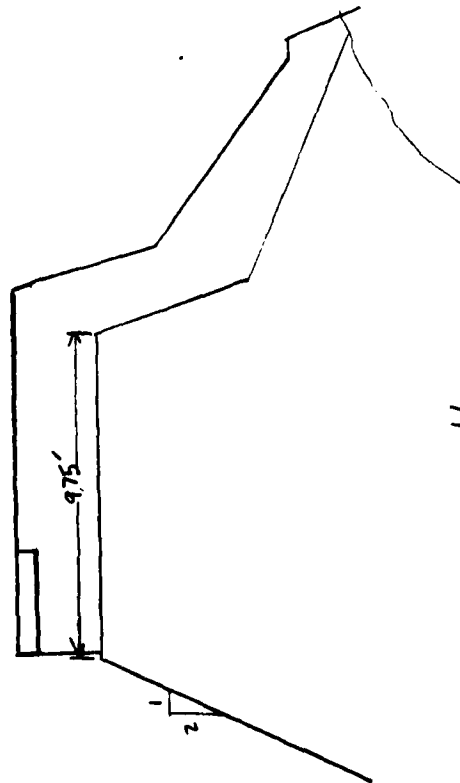
SPILLWAY SECTION

Analysis was based on approximate cross section, shown on following page, developed from measurements made at the time of inspection. A normal analysis was performed, including an overturning analysis, since the dam has a composite cross section consisting of both concrete and laid-up stone. Due to unknown foundation conditions, full uplift was assumed at the upstream toe, decreasing to the tail-water pressure at the downstream toe.
